DESIGN, FABRICATION, INSTALLATION AND FLIGHT SERVICE EVALUATION OF A COMPOSITE CARGO RAMP SKIN ON A MODEL CH-53 HELICOPTER

D.W. Lowry, and M.J. Rich

SIKORSKY AIRCRAFT
DIVISION OF UNITED TECHNOLOGIES CORPORATION
Stratford, Conn.

CONTRACT NO. NAS1-14447
APRIL 1983

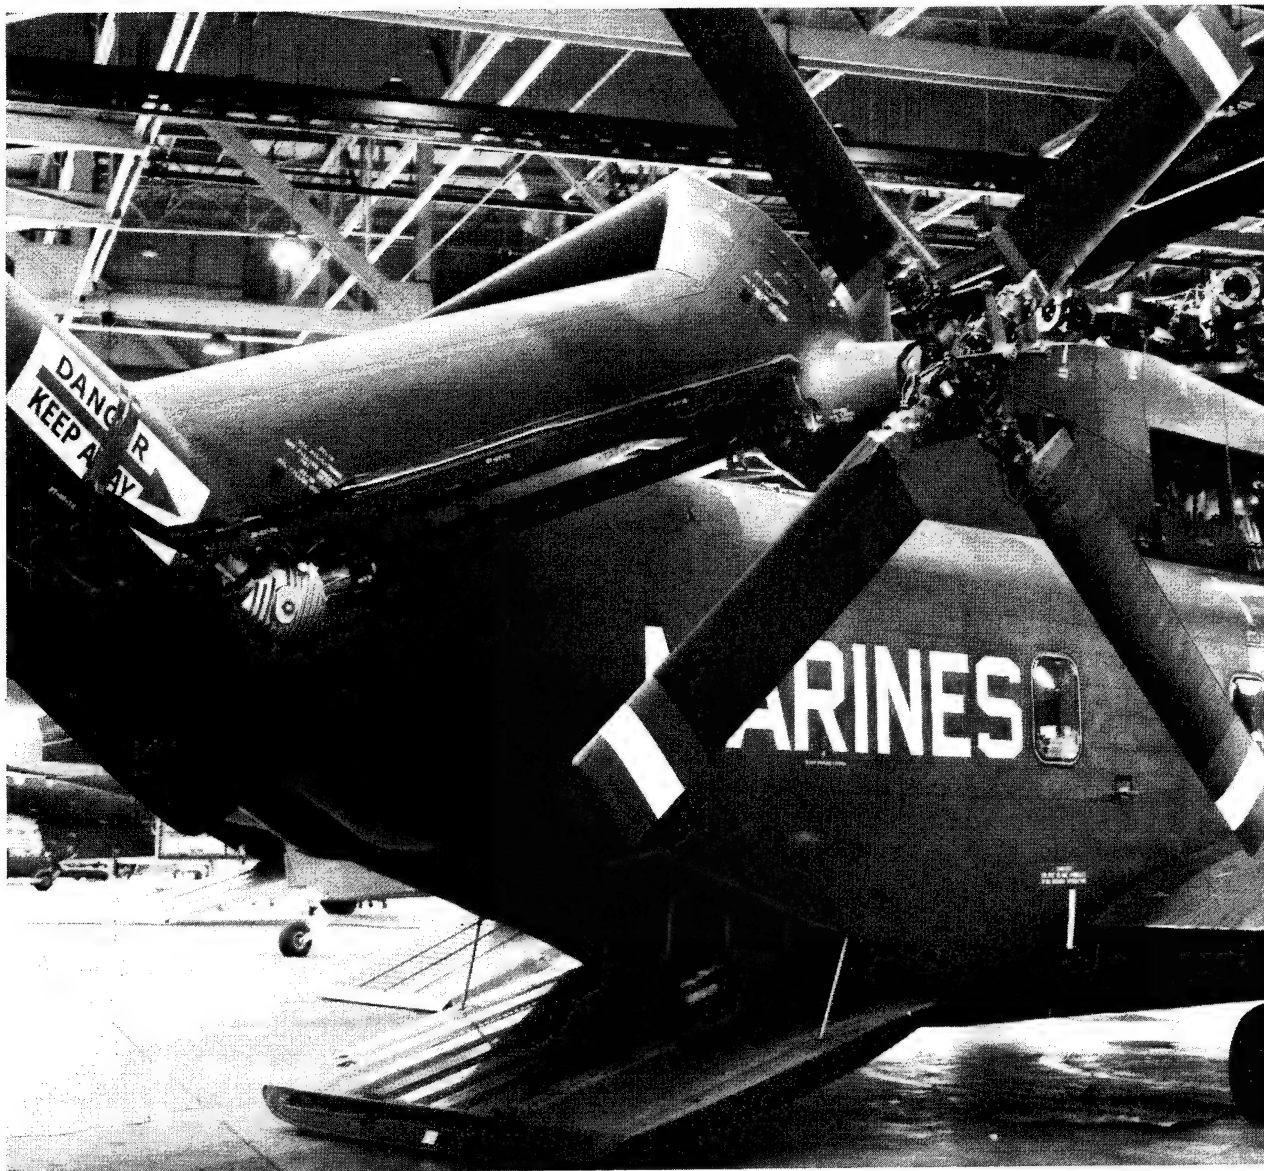
FIGURE 1 CH-53D CARGO RAMP.

There is a need for flight service experience with woven K/E composite material under severe operating conditions. The cargo ramp of the CH-53 Marine helicopter was selected as the candidate structure to assess durability of woven K/E skins. As illustrated in Figure 1, the cargo ramp is located in the aft bottom region of the helicopter fuselage. The aft end of the ramp is subject to possible service damage when it is lowered to the ground for loading. The ramp may also be subjected to damage from ground surface debris.
